McCOOK FIELD REPORT, SERIAL No. 1902

STATIC TEST OF THE LOENING PA-1 SINGLE-SEATER PURSUIT AIRPLANE

Prepared by
D. B. Weaver
Engineering Division, Air Service
McCook Field, Dayton, Ohio
April 10, 1922

STATIC TEST OF THE LOENING PA-1 SINGLE-SEATER PURSUIT PLANE.

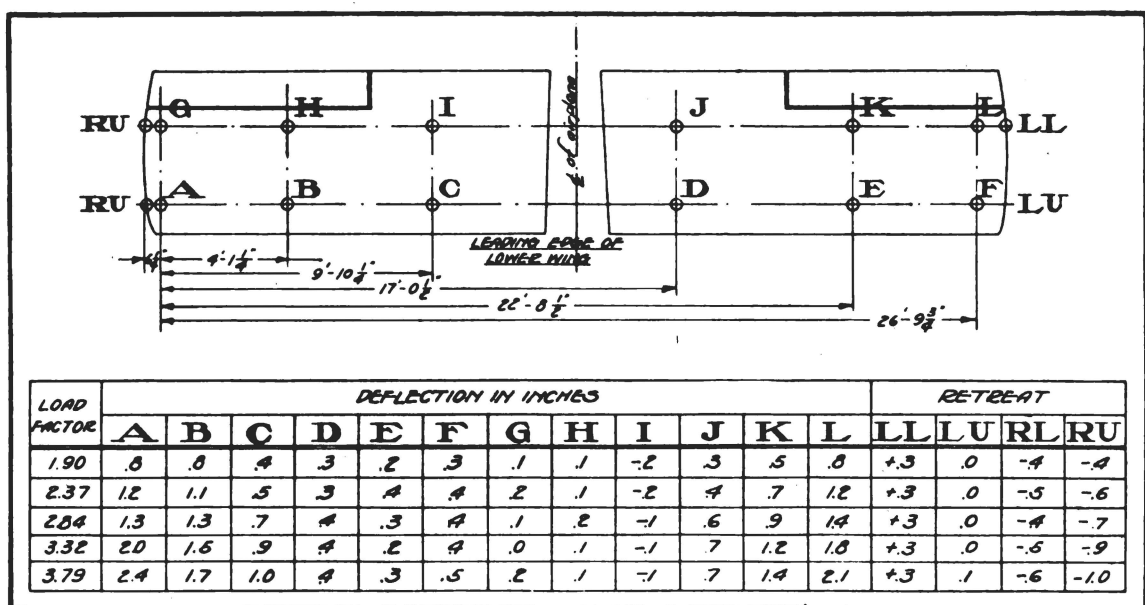
The wing supported the required factor of 3.5 satisfactorily. The bearing surface of the clip which connects the spar to the fuselage had crushed into the spar one-sixteenth

FIG. 11.—Tabulated results of the reverse loading static test of the Loening PA-1.

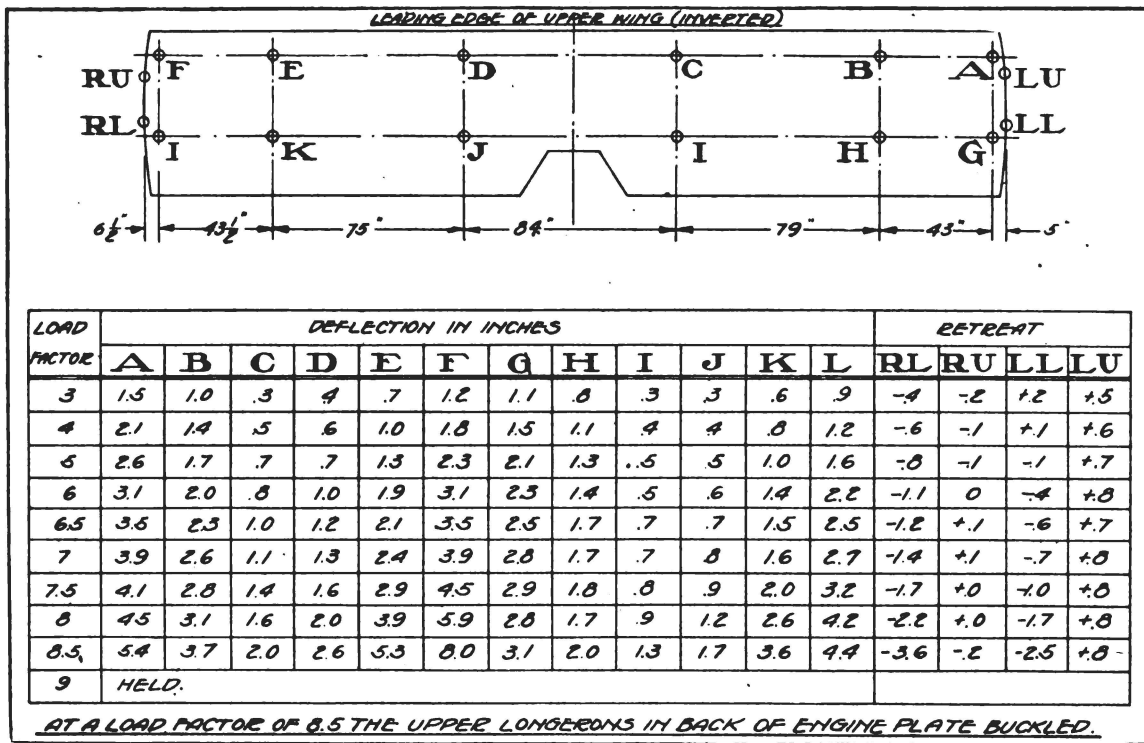
At a required factor of 8.5 the longerons began to bend at the point where the fuselage was supported.

At a factor of 9, the wings held the load satisfactorily, but the test was discontinued due to the weakness of the fuselage.

FIG. 17.—Tabulated results of the high angle of incidence static test of the Loening PA-1.

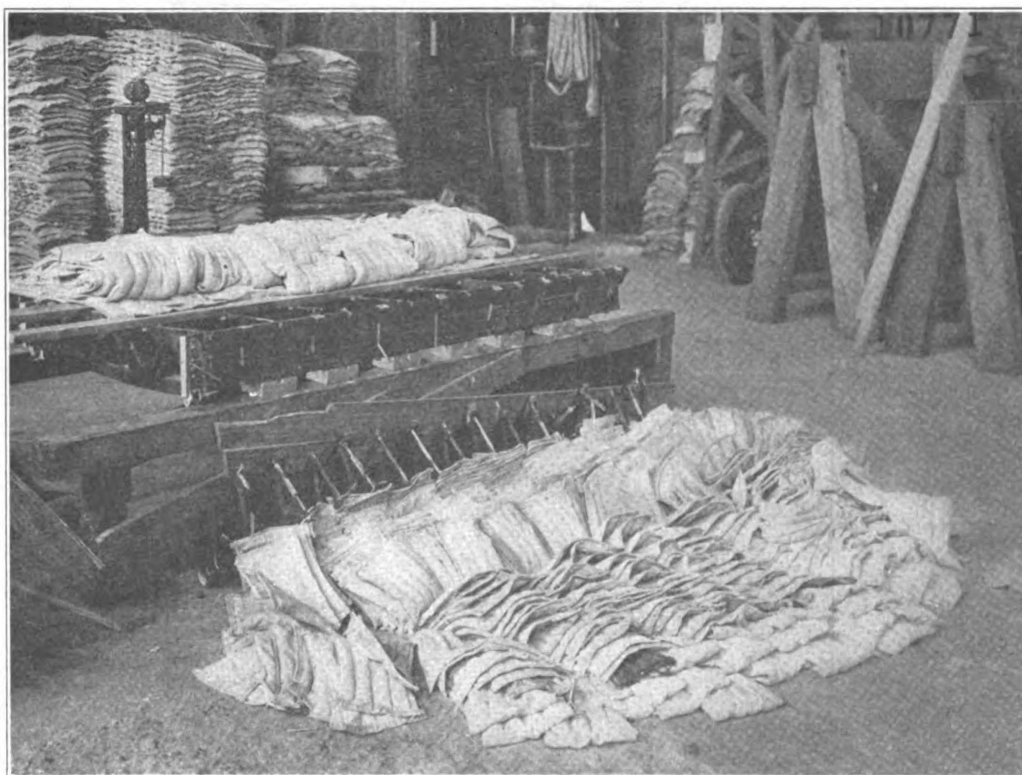
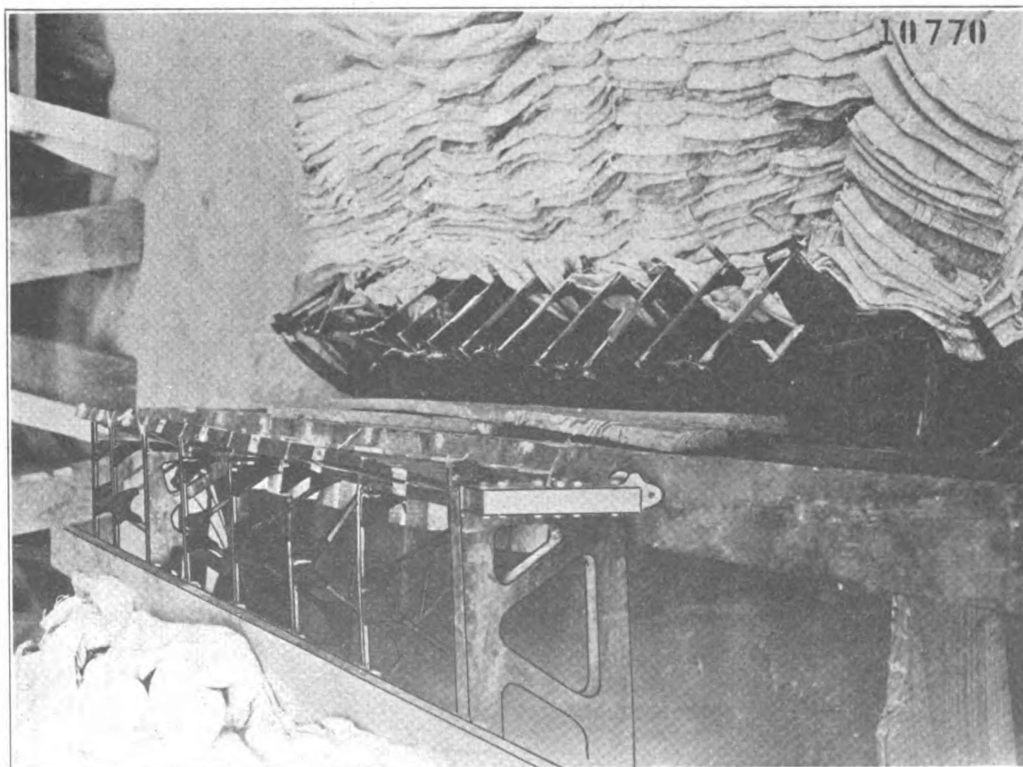
The leading edge failed at a factor of 16.6 (Figs. 19 and 20).

The leading edge stood the test satisfactorily, being 18 per cent stronger than the minimum requirements.

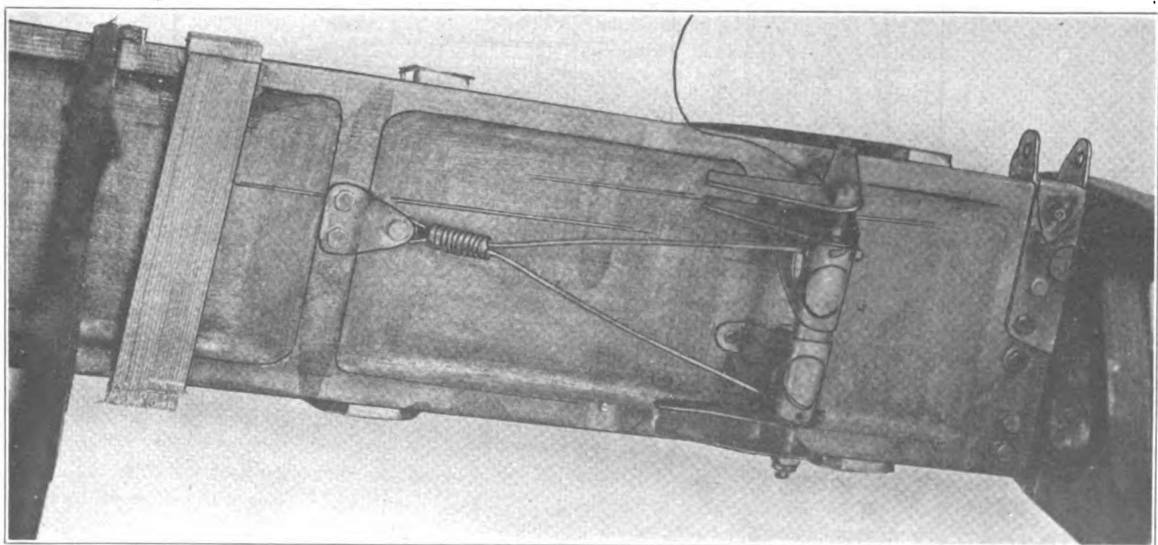
FIG. 24.

At a load of 15 pounds per square foot the pulley brackets bent out of shape and showed signs of pulling away from the spar. The two ribs further out from the compression rib buckled. At 20 pounds per square foot the spar was distorted to such an extent that it split as shown in Figure 24. With the control system discontinued and a rigid connection made to the control mast, the loading was carried to 35 pounds per square foot without failure.

Due to the spar failure it was impossible to finish testing the aileron with the control system connected.

The spar is not strong enough. The pulley bracket and the location of the compression rib are unsatisfactory. The aileron is structurally as strong as required.

Redesign the lower rear spars, the aileron control cable pulley bracket, and relocate the compression rib.

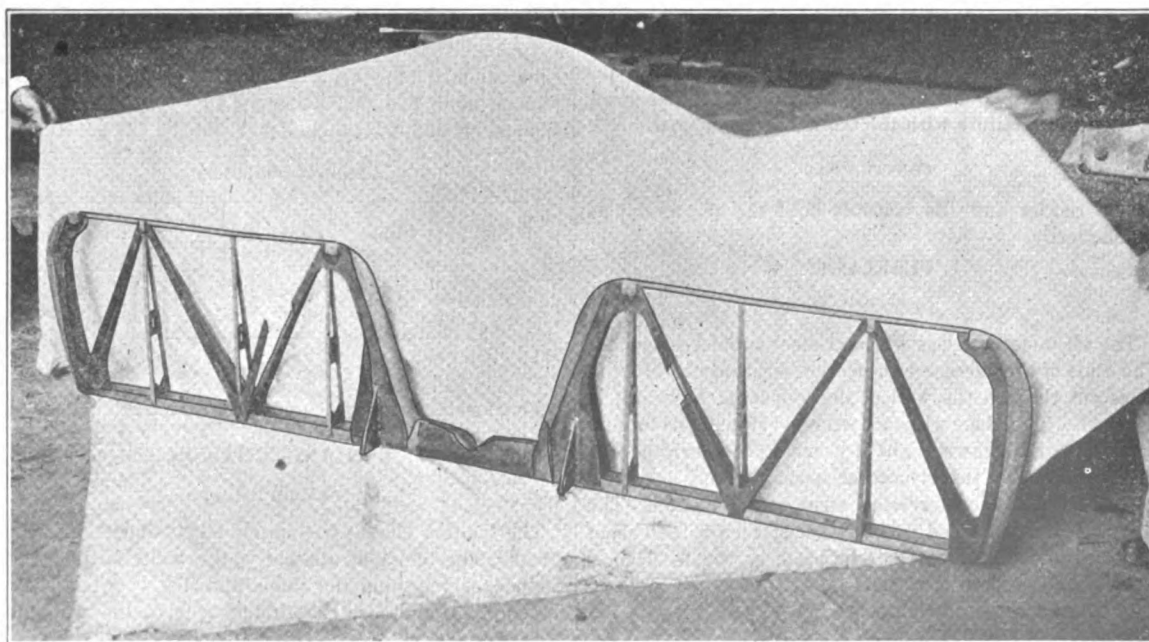
FIG. 27.

figure 26. The failure, with both sides of the elevator broken, is shown in figure 27.

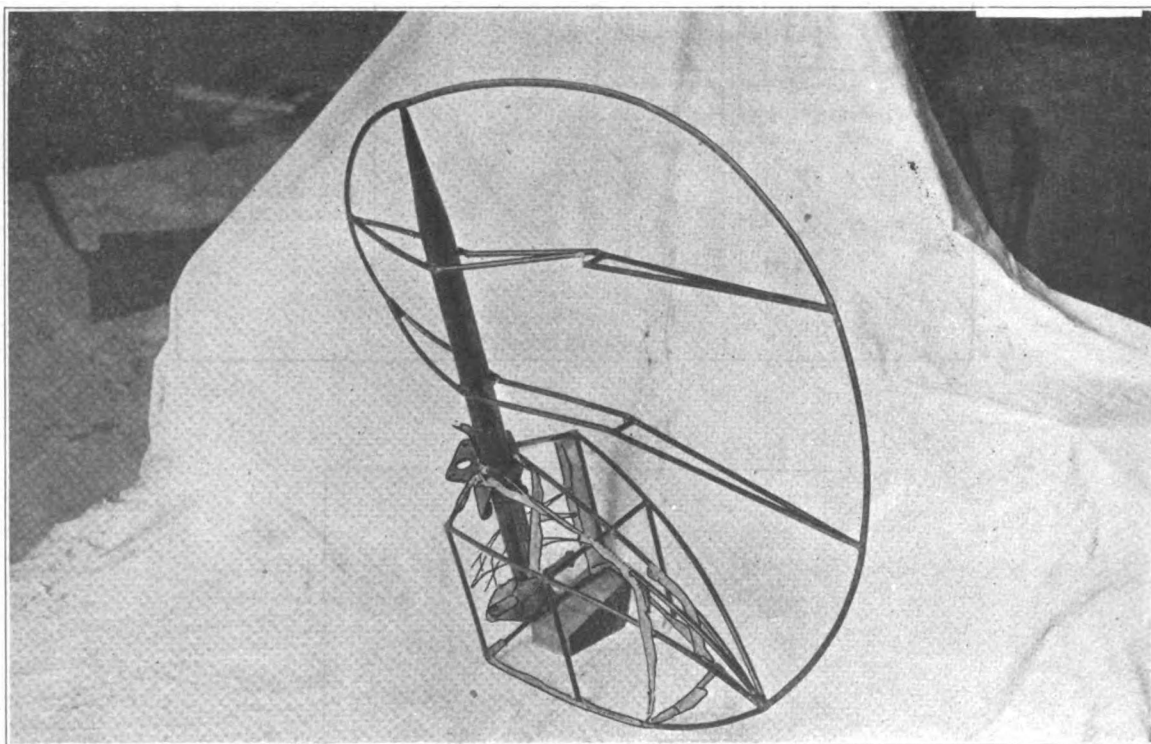
FIG. 30

The rudder supported the required load of 30 pounds per square foot without failure. The loading was continued until failure of the ribs resulted at 47.5 pounds per square foot. Figure 29 gives the pull necessary to actuate the rudder under load and the deflection of the surfaces at the points indicated. Figure 30 is a photograph of the rudder failure with the fabric cover removed.

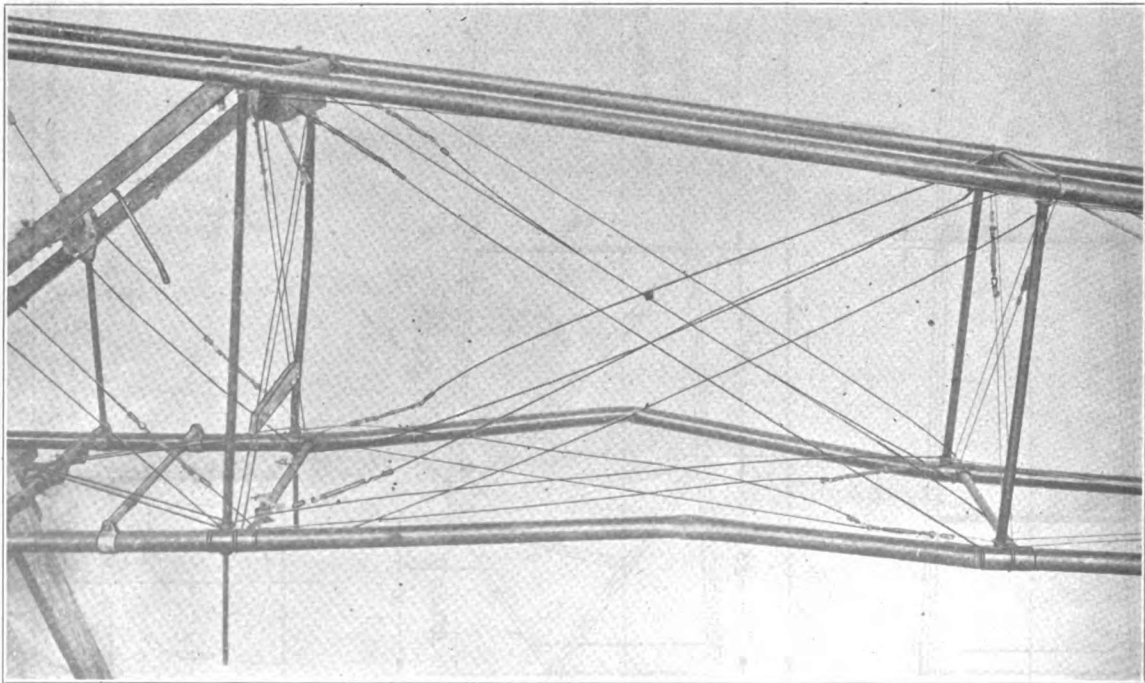
FIG. 33.

When the jacks were let down at a load factor of 4, the right upper wing spars failed in compression, the ribs failed in compression, and a drift wire pulled in two. A load factor of 7.5 was supported for three minutes, when a wire in the second to the last bay, left side, failed. The wire was replaced, and after supporting a factor of 8 for five minutes failed again. With a three-sixteenth inch flexible steel cable in place of the wire the test was continued. The lower longerons buckled in the third bay from the tail end, at a factor of 8. Figure 33 is a photograph of this failure.

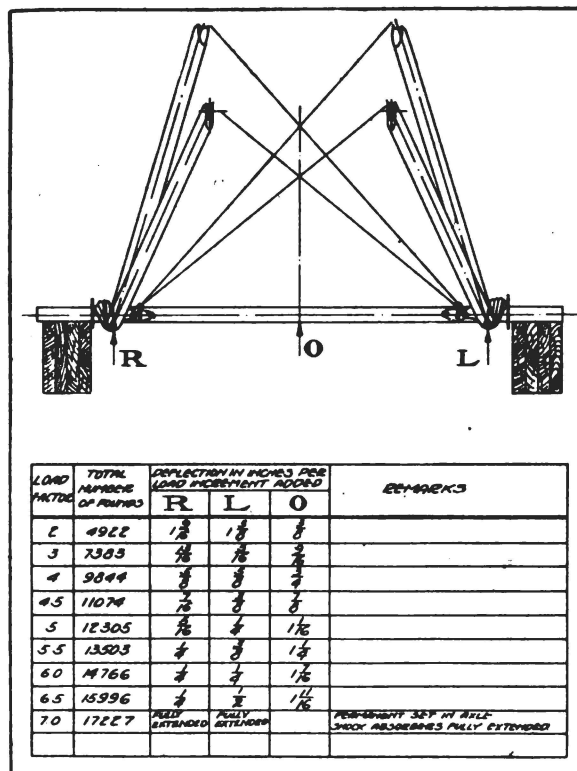
FIG. 35.—Static test results of the Loening PA-1 landing chassis.

Tabulated results are given in figure 35. The axle showed a permanent set, and the shock absorber chord was fully extended at a load factor of 6.5. The struts held a load factor of 7 without failure.
